INSPECTION REPORT

For the Property at:
1234 PEACHTREE AVE
ATLANTA, GA 30312

Prepared for: JAMES MCMANN
Inspection Date: Wednesday, March 15, 2023
Prepared by: Steven Fish

RE: Report No. 1041, v.0
1234 Peachtree Ave
Atlanta, GA
30312

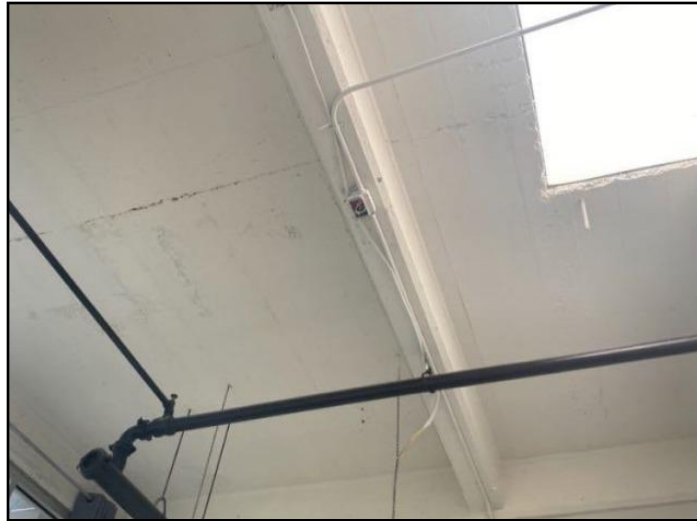
3. Unit# 254 Conference Room

5. Condition: • Missing on switches, outlets and junction boxes

Location: Unit# 254 Conference Room

Task: Correct

Time: Immediate

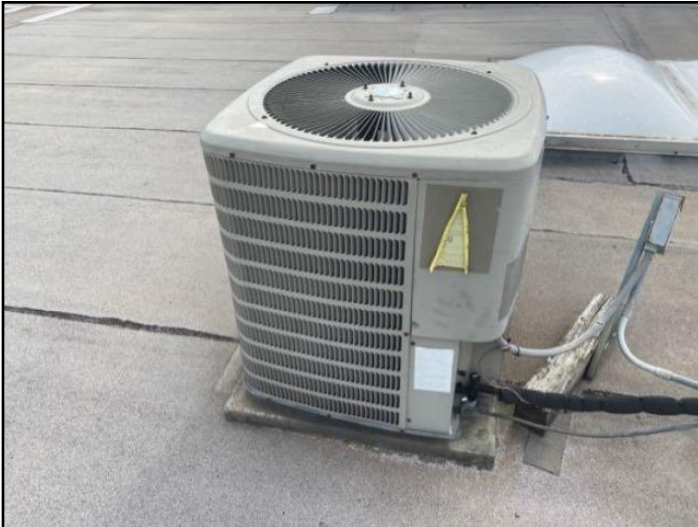
8. Unit#254 Heat Pump

Condition: • Approaching end of typical life expectancy

- Between 11 and 15 years old

10. **Condition:** • Approaching end of typical life expectancy

Task: Replace

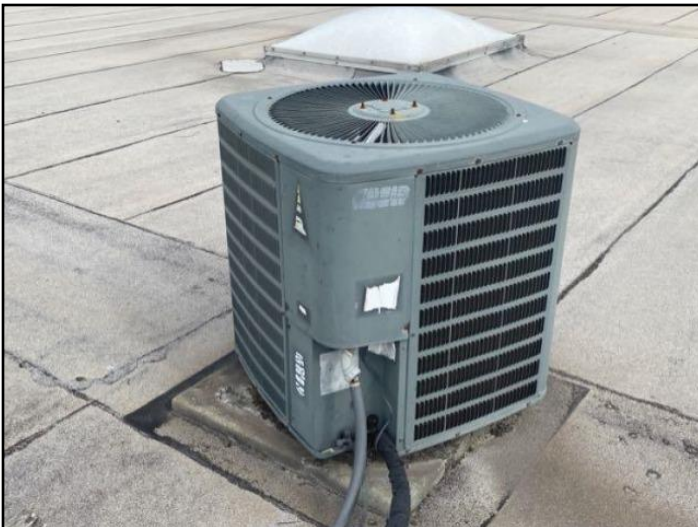
10. Unit#255 Heat Pump

Condition: • Approaching end of typical life expectancy

- Between 5 and 10 years old

11. **Condition:** • Approaching end of typical life expectancy

Task: Replace

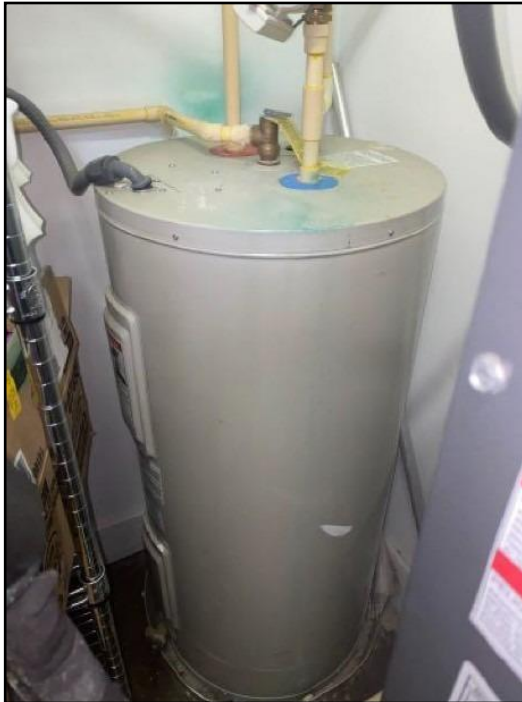
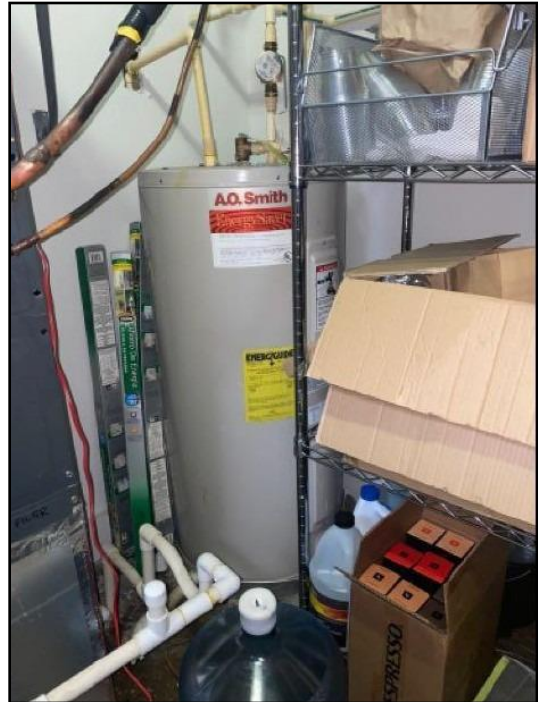
Condition: • Beyond its expected useful life

Both units are 24 years old

26. **Condition:** • Beyond its expected useful life

Task: Replace

Time: When necessary

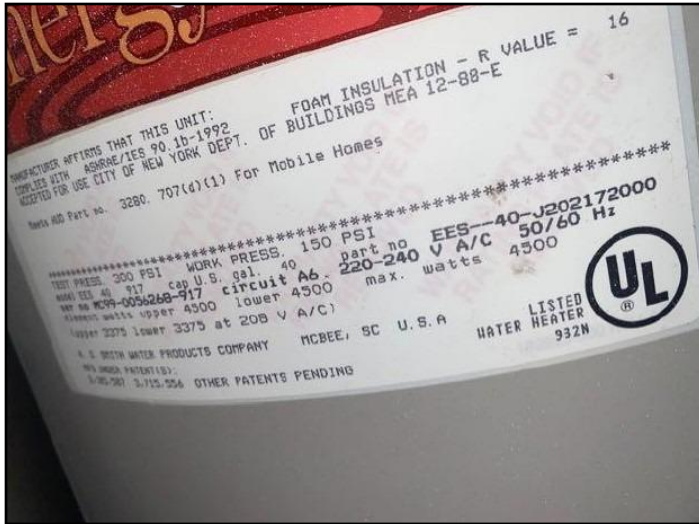
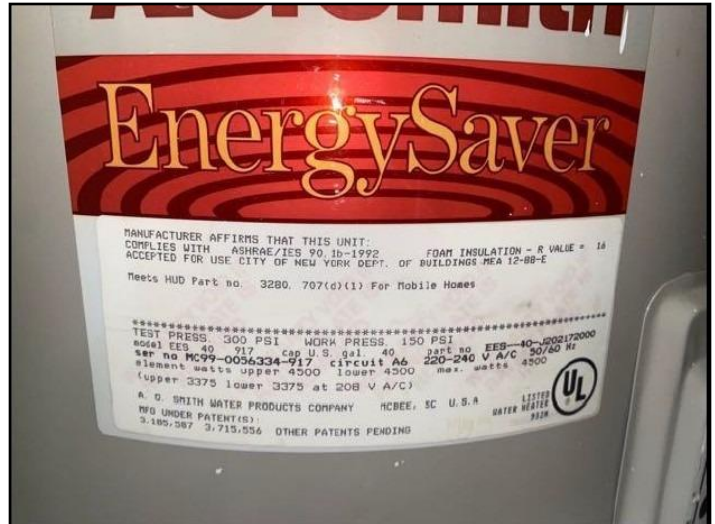
Typical domestic water heater/boiler life expectancy: • 15 years

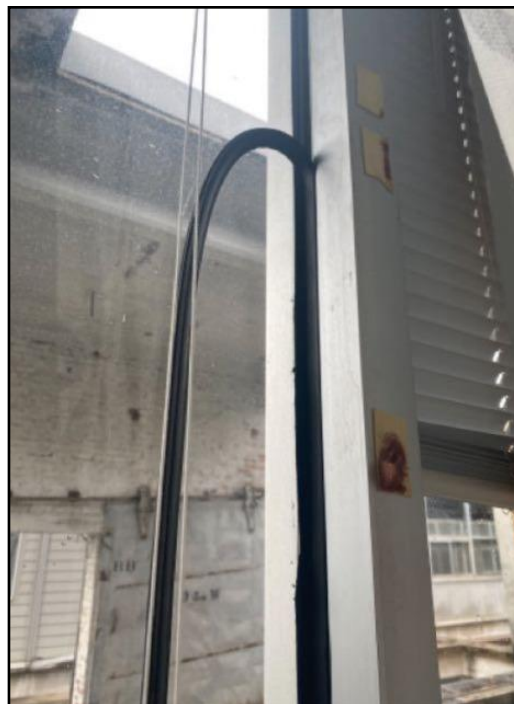
28. Unit#254 Office

42. **Condition:** • Loose/ missing/ damaged weather stripping

Task: Repair or replace

Time: Immediate

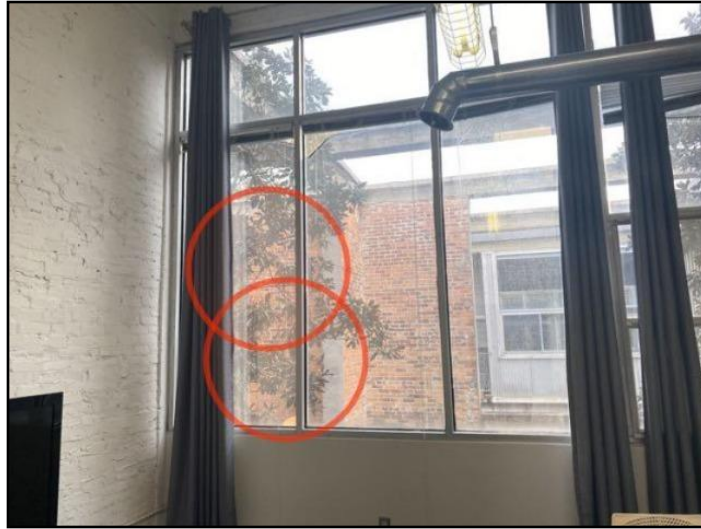
29. Unit# 254 Conference Room

Condition: • Cracked pane

Location: Unit# 254 Conference Room

43. **Condition:** • Cracked pane

Task: Replace

Time: Immediate
