INSPECTION REPORT

For the Property at:
813 OFFICE PARK ROAD
SMYRNA, GA

Prepared for: JOHNNY JOHNSON
Inspection Date: Wednesday, July 19, 2023
Prepared by: Steven Fish

RE: Report No. 1042
813 Office Park Road
Smyrna, GA

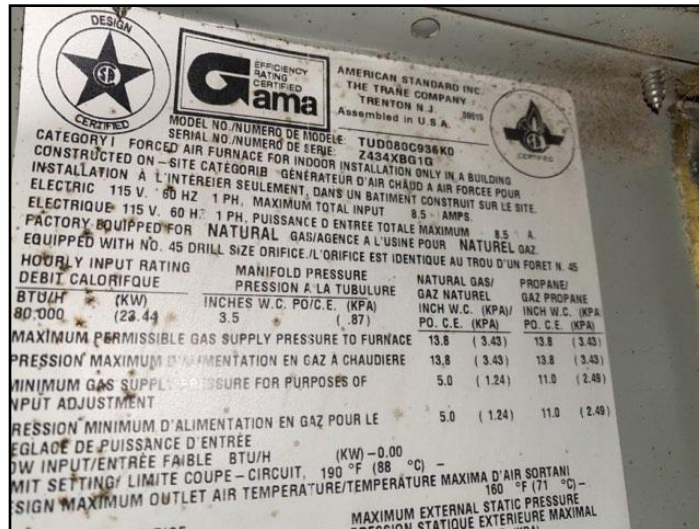
2.

Furnace #1 - Age and type:

- Between 16 to 20 years old
- 2004

7. **Condition:** • Approaching end of typical life expectancy
Unit believed to be for the apartment is over 20 years

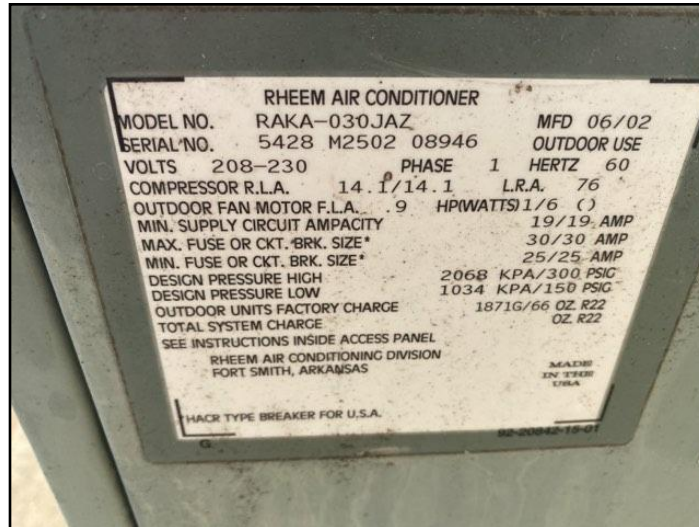
12.

Split system condenser coil #1 - Age and compressor type:

- Over 20 years old

17. Condition: • Beyond typical life expectancy
Unit believed to be for the apartment is over 20 years

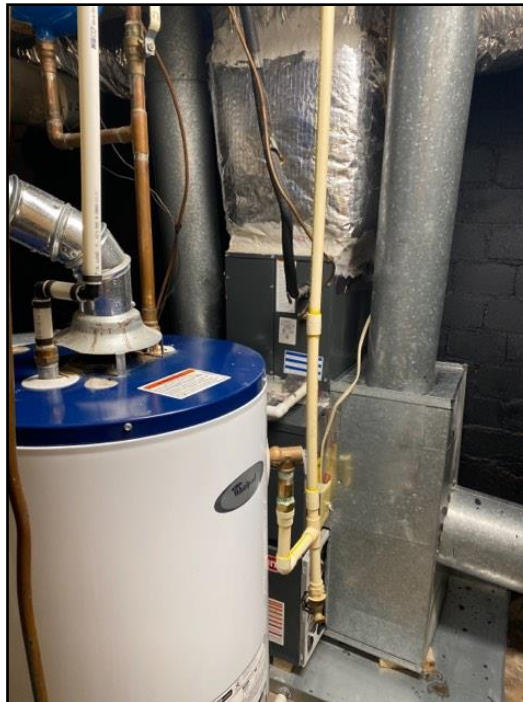
22.

30. **Condition:** • Temperature Pressure Relief Valve discharge pipe runs verticle

Location: Basement

Task: Improve

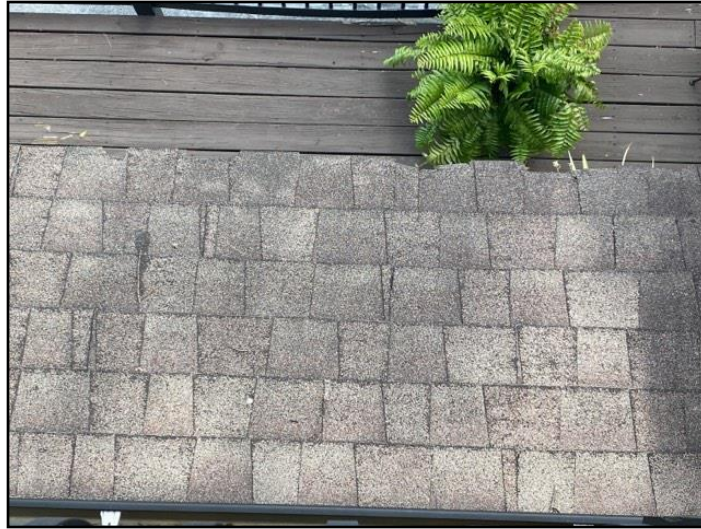
34.

39. Condition: • Damaged

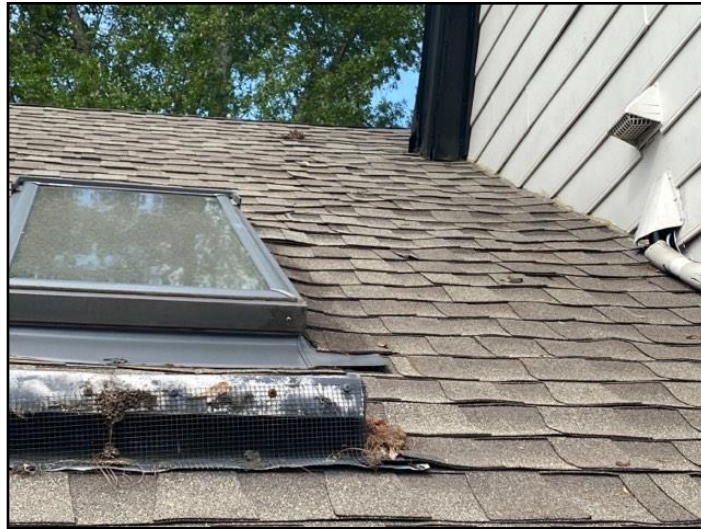
35.

40. Condition: • Cupped

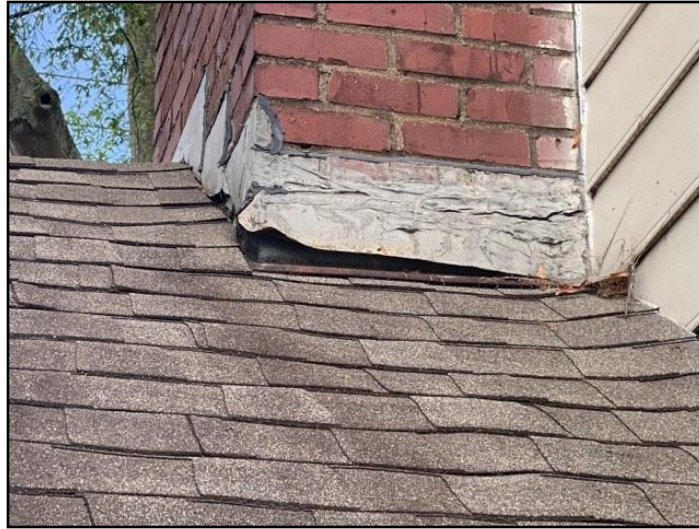
36.

41. Condition: • Loose

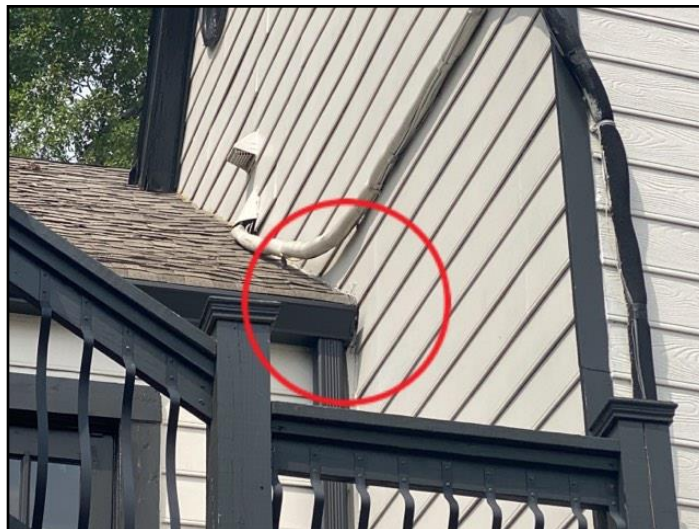
37.

42. Condition: • Kick out flashing missing

Task: Correct

Time: Immediate

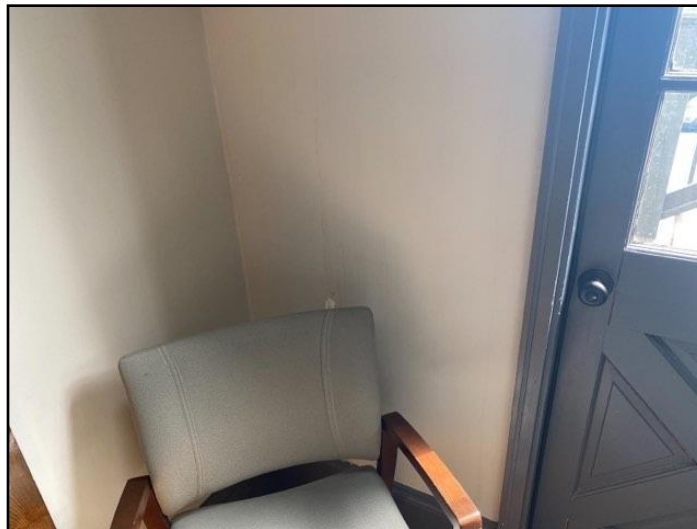
38.

49. Condition: • Staining

Location: Office

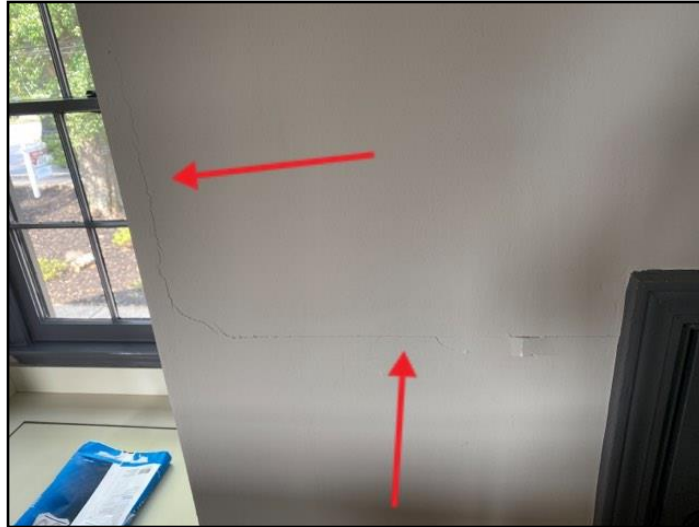
39.

50. Condition: • Typical cracking

Location: Second Floor Office

Task: Improve

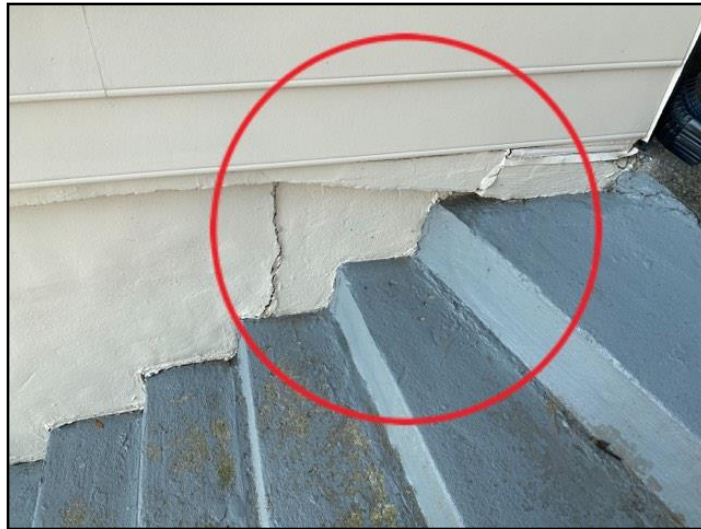
40.

61. Condition: • Settlement cracks noted

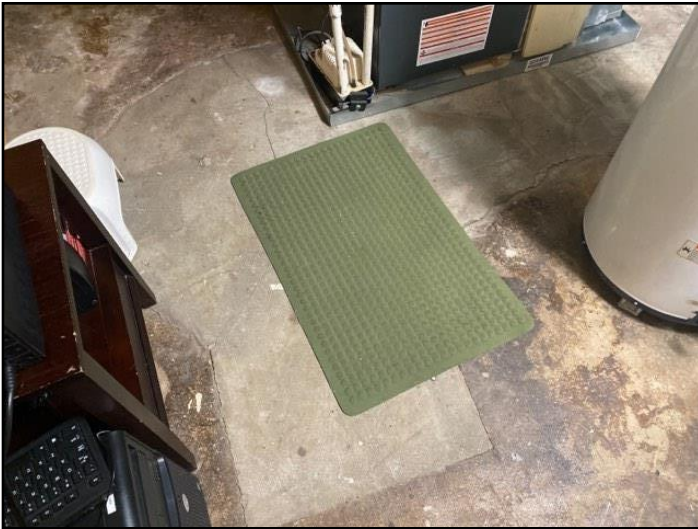
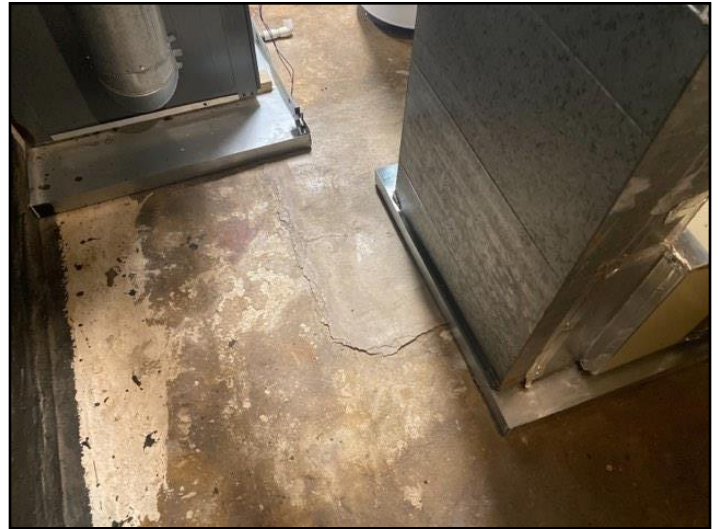
63. Condition: • Patch repairs noted

Location: Basement

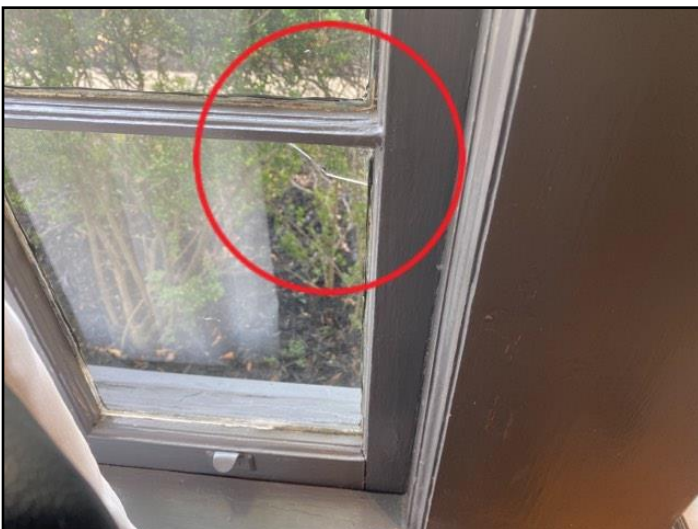
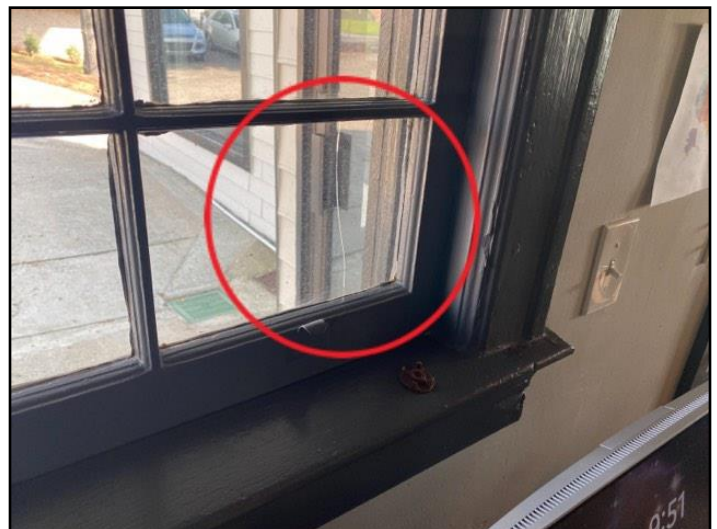
73. **Condition:** • Cracked pane

Location: Reception Area, left side office, Second Floor Office

Task: Repair or replace

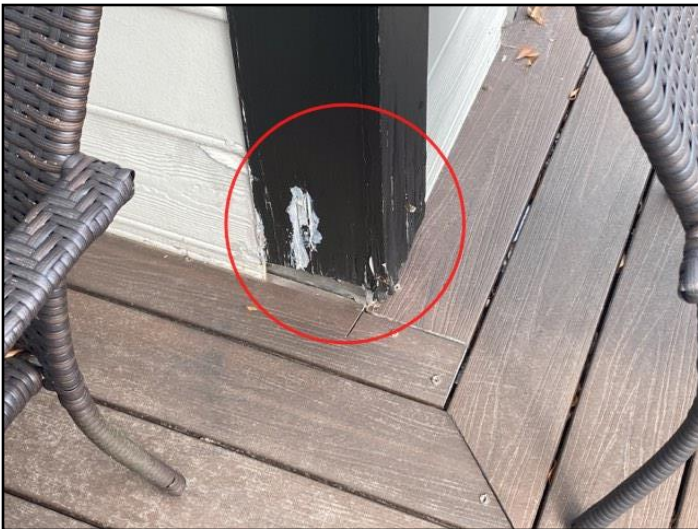
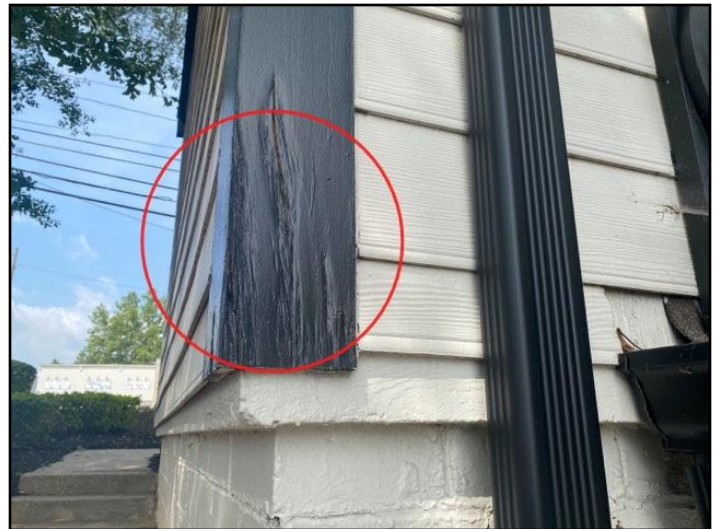
75. Condition: • Rotted

Task: Improve

Time: Regular maintenance

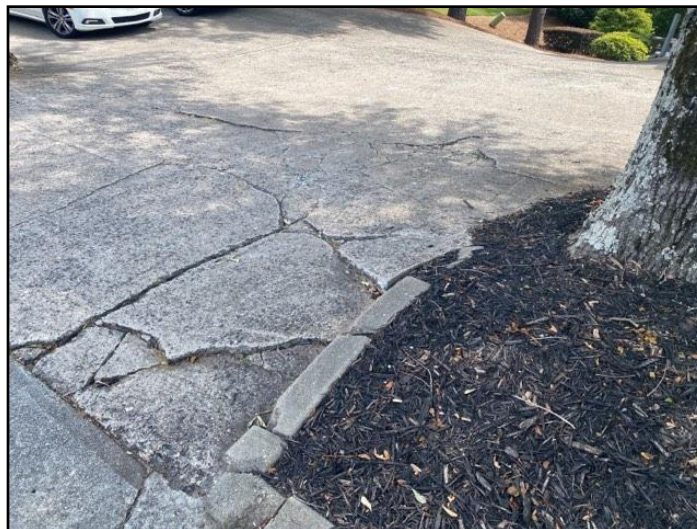
56.

80. Condition: • Large cracks

May be caused by tree root damage. Further evaluation recommended

Task: Repair or replace

Time: Immediate

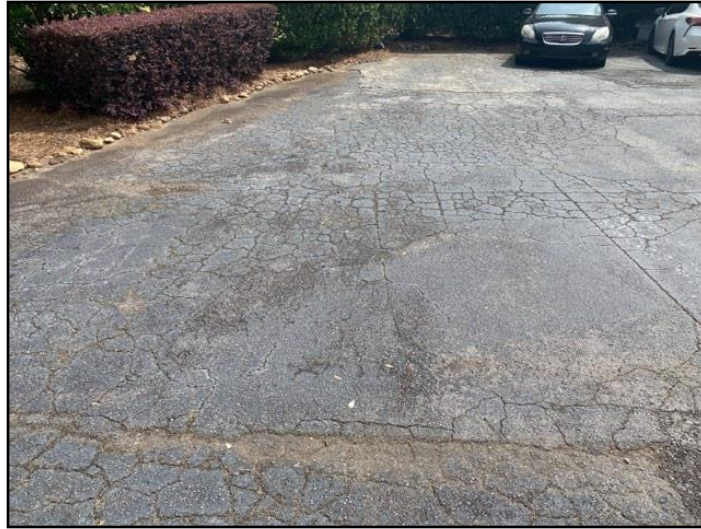
57.

81. Condition: • Local surface deterioration

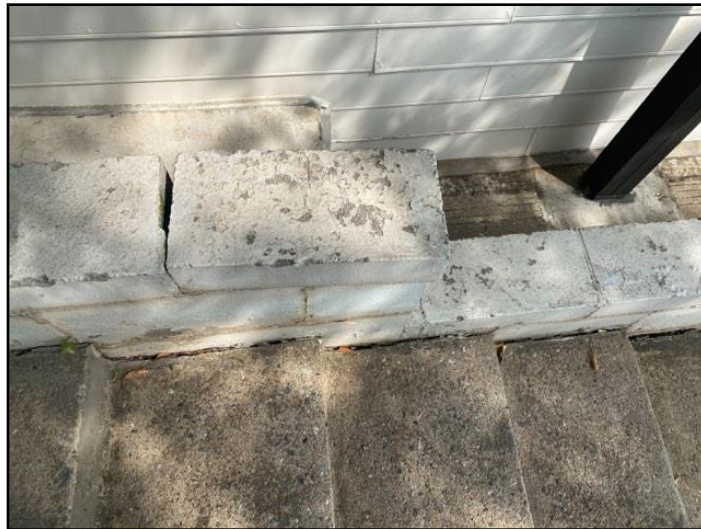
58.

82. Condition: • Deteriorated

Task: Repair or replace

Time: Regular maintenance
