# INSPECTION REPORT

For the Property at:  
**296 QUINCY AVENUE**  
ATLANTA, GA 30316

Prepared for: JOHN BENDER  
Inspection Date: Monday, October 2, 2023  
Prepared by: Steven Fish

RE: Report No. 1045  
296 Quincy Avenue  
Atlanta, GA  
30316

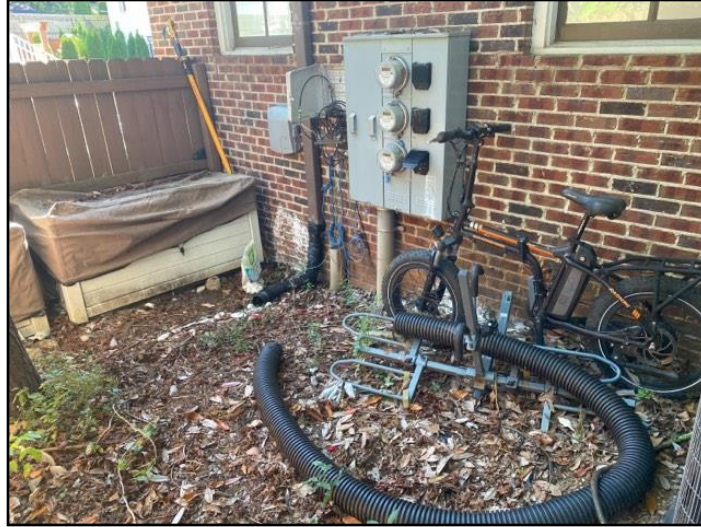
5. *Right Side*

4. **Condition:** • Storage within one meter of equipment

**Task:** Remove

**Time:** When necessary

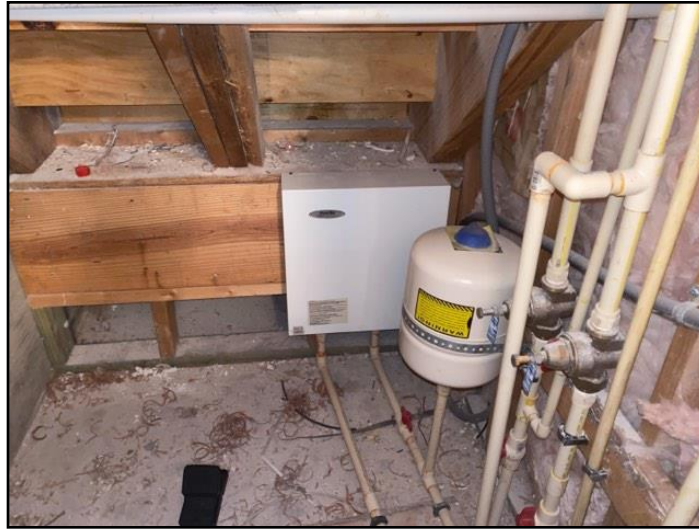
18. Water Heater Unit 1

**Domestic water heater/boiler - approximate age:** • Between 10 and 15 yrs old

**28. Condition:** • Approaching the end of its expected useful life

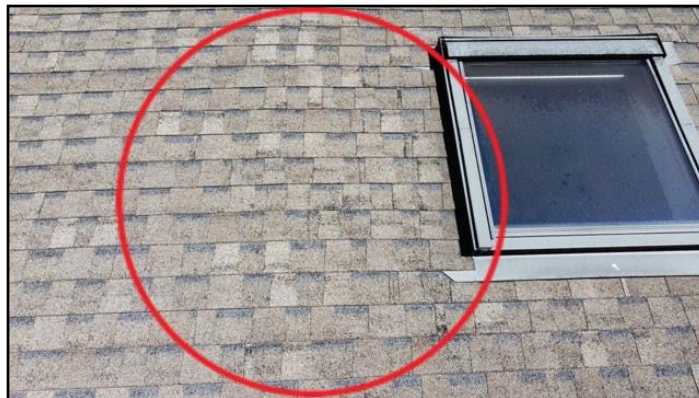
27. Left Side

**35. Condition:** • Damaged

Typical granular loss and damage

**Task:** Monitor

**Time:** Unpredictable Regular maintenance

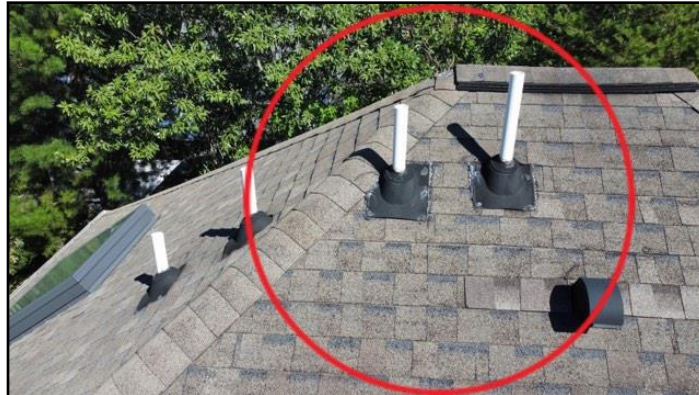
28. Left Side

**36. Condition:** • Sealant is cracking

**Task:** Repair

**Time:** If necessary Regular maintenance

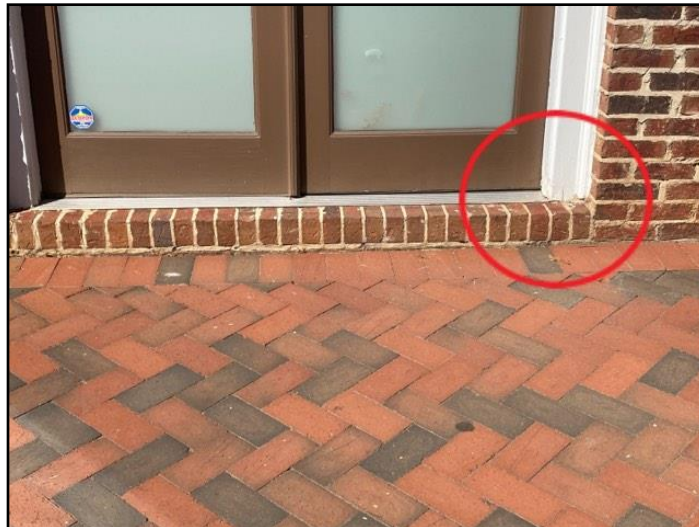
35. *Front*

61. **Condition:** • Rotted

Door trim previously repaired

**Task:** Repair or replace

**Time:** Regular maintenance

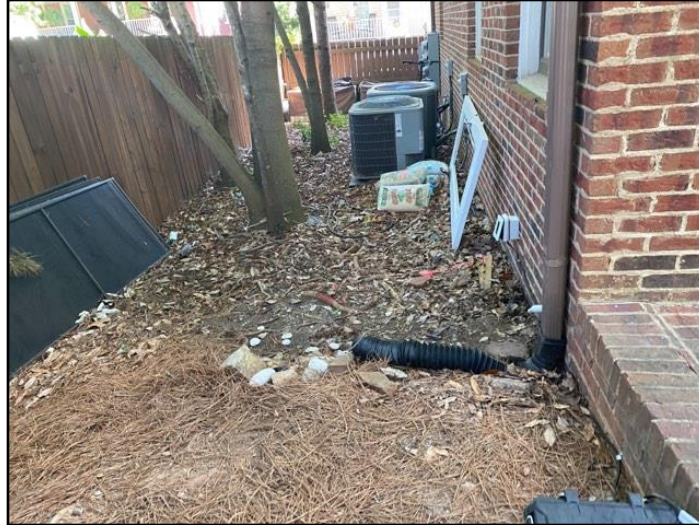
36.

**66. Condition:** • No major deficiencies were noted  
Sump pump drainage was noted on the right side of the building.

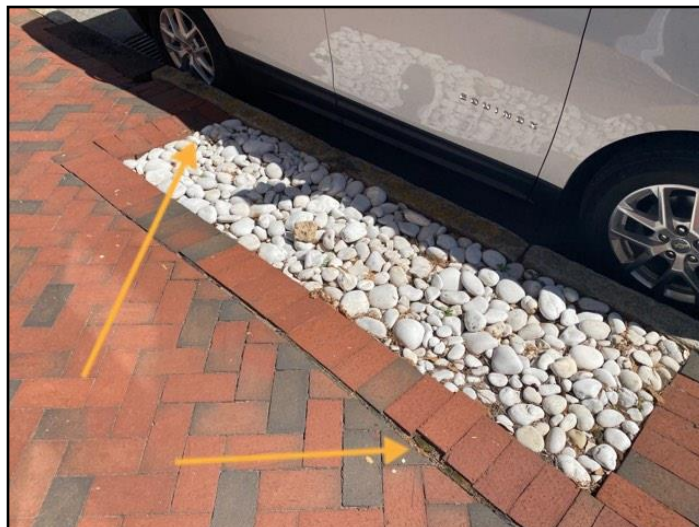
37. Front

**67. Condition:** • Settled relative to the curb  
It was not determined who is responsible for the repair and maintenance of this area. Request disclosure

**Task:** Improve

**Time:** Immediate
